Machinery Messages

Case History

The importance of monitoring Shaft Centerline data

by Mark A. Jordan,
Vibration Specialist
Bently Nevada Corporation

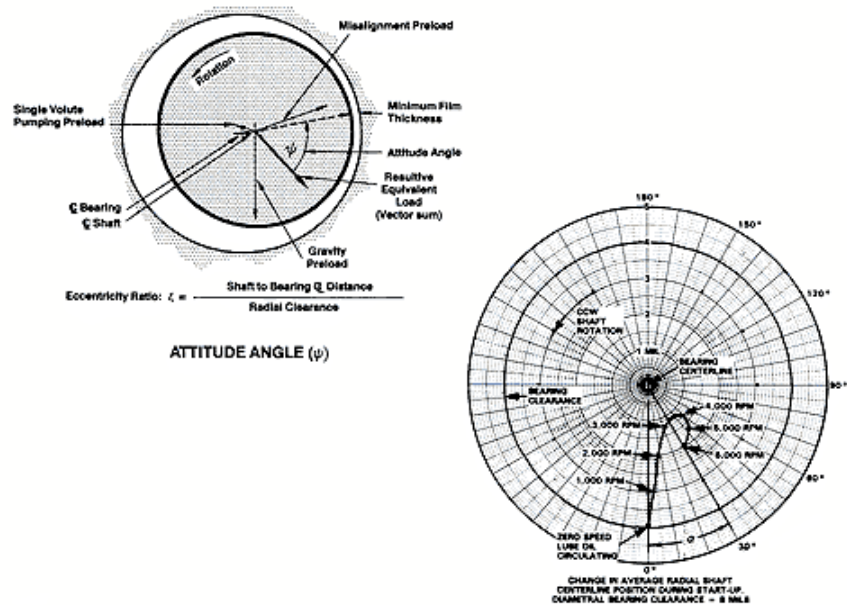
Figure 1

Shaft attitude angle definition (left). An example of how the shaft radial average centerline position changes during startup (right).

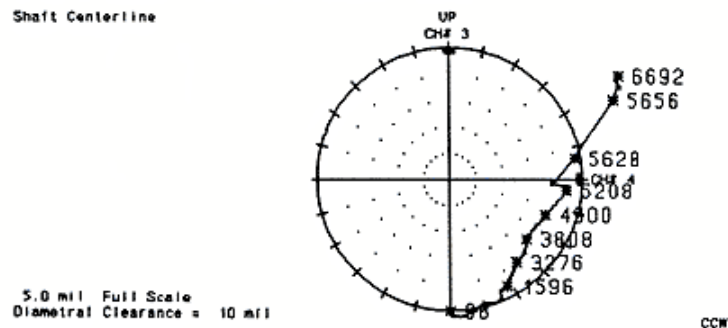
Figure 2

Shaft centerline data showing excessive rotor travel beyond the diametral bearing clearance at 6692 rpm. This plot also shows the total rotor travel from startup where α is approximately 130° from vertical.

Further inspection of orbital and spectral data did not indicate a malfunction. As time progressed, however, steady state data on both turbine bearings showed sudden minor changes in amplitude and phase although no changes were observed at the compressor bearings. Only by looking at Shaft Centerline data was it apparent that something was terribly wrong. As shown in Figure 2, the inboard turbine bearing shaft position exceeded the diametral clearance by 2 mils (51 μm) at operating speed.

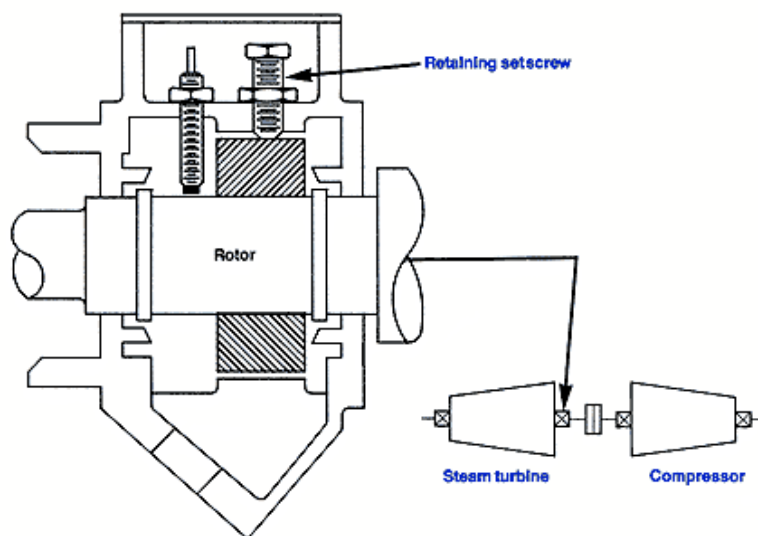
Figure 3

As plant personnel were making provisions for a forced shutdown to check alignment, examination of OEM drawings, specifically of the inboard turbine bearing, drew suspicions toward a bearing retaining setscrew. The assumption was, if this screw were loose, the effect of having no upper bearing restraint would be seen, which would be responsible for rotor travel beyond the diametral bearing clearance.

This setscrew is located on the top of the inboard bearing carrier (Figure 3) and is the sole component for restraining the upper bearing carrier. The recommended OEM torque setting for this setscrew is 20 lb ft (27 N•m). The screw is accessible upon removal of an external coverplate on the bearing housing. Subsequent inspection (prior to shutdown) revealed this screw was loose!

Machine drawing showing the inboard turbine bearing. Note the location of the bearing retaining setscrew.

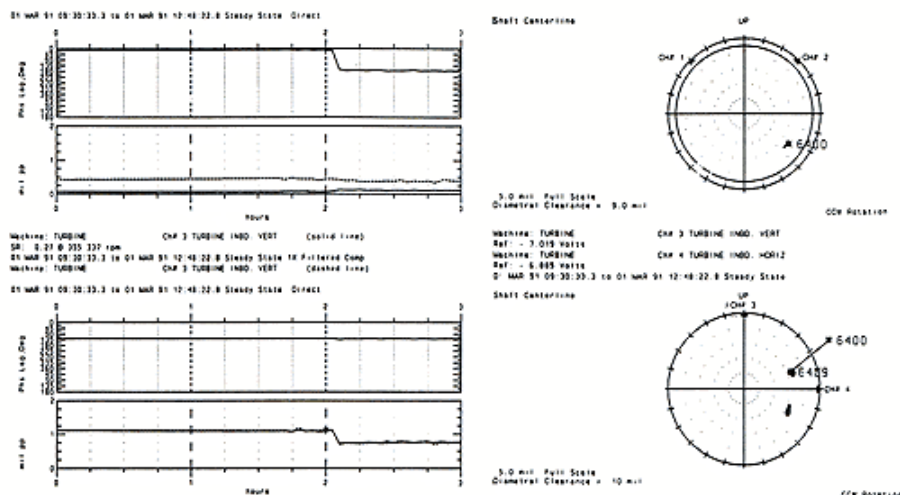
Plant management decided to tighten the screw with the machine running at normal operating speed. Figure 4 clearly shows the resulting abrupt change in Shaft Centerline position which forced the rotor to return to a position within the diametral bearing clearance as the screw was tightened.

This action increased the rotor preload significantly, which was reflected mainly in the orbital data along with a shift in 1X amplitude and phase at both turbine bearings. For the most part, the compressor was unaffected.

Changes in 1X amplitude and phase (left), along with the change in Shaft Centerline data (right) occurred when the inboard bearing setscrew was torqued to 20 lbs ft (27 N•m). This action resulted in increased rotor preload and confirmed that misalignment was present in the system.

By looking at the lower Shaft Centerline plot (Figure 4), it became obvious that the rotor position was still too high at the inboard bearing location. The turbine alignment figures were recalculated based on the latest set of hot readings, and thermal growth factors were calculated from the last cold readings. Actual corrective alignment moves on the turbine, incorporating Shaft Centerline data as an additional reference, were:

Horizontal: The turbine case was moved to the right 0.003 inch (79 μm). This resulted in the rotor being moved toward the center of the plot.

Vertical: The turbine case was raised 0.009 inch (229 μm). This resulted in the rotor being moved toward the lower half of the bearing.

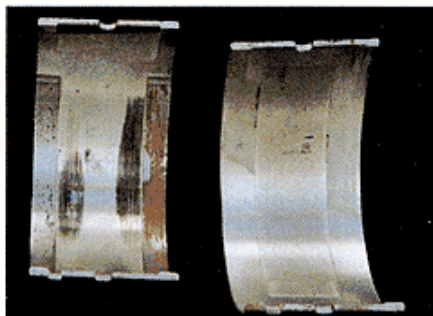
Figure 5

Inboard turbine bearings showing wear due to misalignment and the loose setscrew.

A subsequent bearing inspection found damage to both upper and lower bearing shells on the turbine inboard side. The upper bearing shell exhibited wear in the same location as the rotor position shown in Figures 2 and 4. Refer to Figure 5. Both shells were replaced and the bearing clearance was checked using Plastigage. The diametral clearance was recorded at 0.010 inch (254 μm).

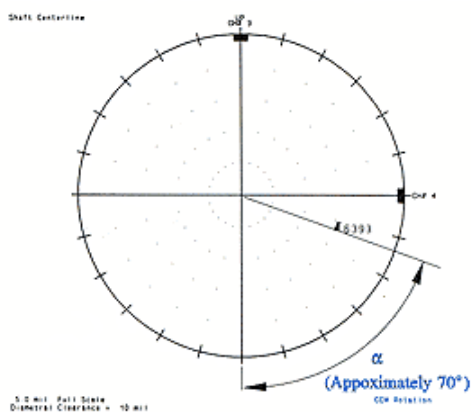
The final running speed position at the inboard turbine bearing. Note the attitude angle, α , has been reduced from 130° to approximately 70°.

By using Shaft Centerline data, in conjunction with regular alignment techniques, the realignment process was performed with a *higher* degree of confidence. Figure 6 shows the final operating speed position of the rotor within the bearing. Since this procedure, the machine has not experienced any further problems.
